**CHROMATE FILM USED FOR CHEMICAL CORROSION CONTROL  
ON GOLD-PLATED PCB CONNECTORS**

E.G. SHAFRIN, J.S. MURDAY

*Naval Research Laboratory, Washington, DC 20375, USA*

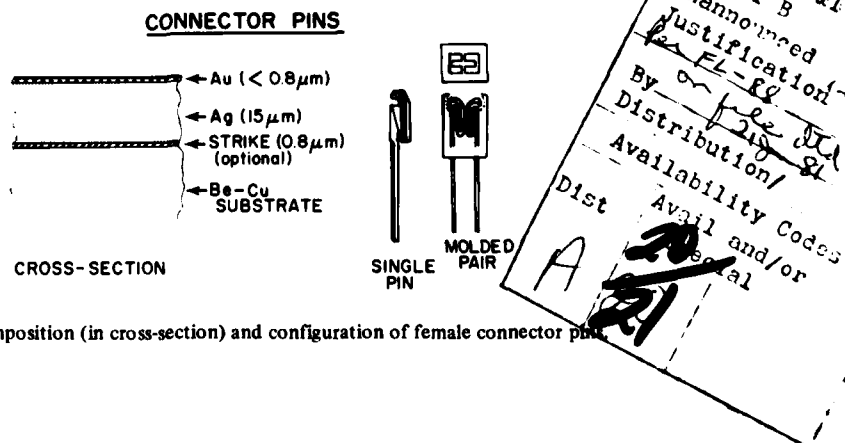
The bellow-form spring female pins (fig. 1) in the electrical connectors are fabricated principally from a resilient beryllium-copper alloy, but rely for their corrosion protection on the thin surface coatings shown in the cross-section. The purpose of the gold plate is to prevent tarnish formation by the silver and thereby maintain a contact surface of low resistance. However, it is well known that defects in the Au film can lead to formation of silver sulfide with subsequent rapid migration across the gold surface [4,5,6]. This tarnish is forming on the MARDAN contacts and its deleterious effect is augmented by the presence of accumulated organic material.

Fig. 1. Composition (in cross-section) and configuration of female connector pins.

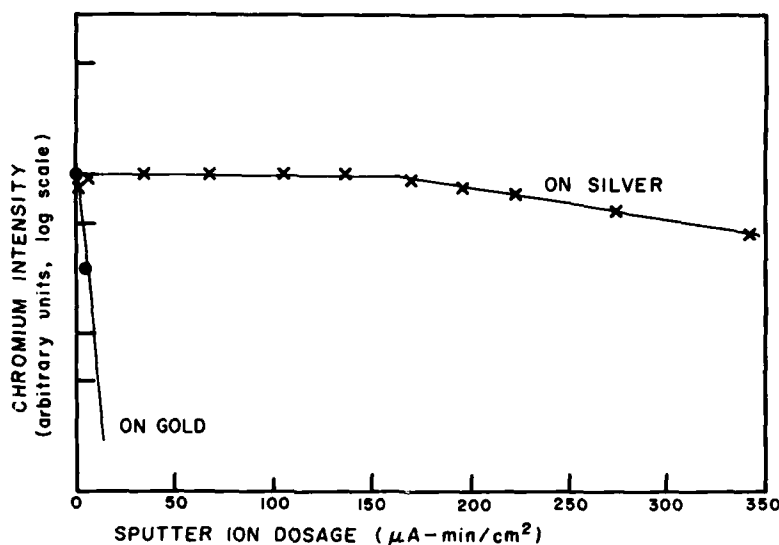
In order to be effective in retaining low contact impedance while preventing Ag tarnish on the electrical connectors, the chromate film growth must not result in a thick film on top of the Au plate, but at the same time must somehow protect any defect in the Au which exposes Ag. Pure Au alone is not expected to show any film formation via the chromating process. Tests on bulk Au showed that some chromate film did deposit. The small amount, estimated to be less than a monolayer (see fig. 2), may have been caused by Ag known to be present as a contaminant in the Au sample. A pure silver sample, on the other hand, showed considerable film growth as shown by its depth profile in fig. 2. The sputter rate of the chromate-induced film is not known, but a sputter rate of  $7 \text{ \AA}$  per  $\mu\text{A}\cdot\text{min}/\text{cm}^2$  has been reported for  $\text{Cr}_2\text{O}_3$  grown by air exposure of clean chromium metal surfaces and bombarded with 3.0 keV argon ions [14]. An Ag AES signal intensity was detected throughout the depth profile and grew stronger as the film etched away. While this could be interpreted as increasing exposure of thinly covered Ag islands, it is more likely that Ag is incorporated into the film; Katzman et al. [8] observed similar incorporation of Al in chromate films grown on that metal.

Fig. 2. Auger sputter profile of chromate films on pure metals.

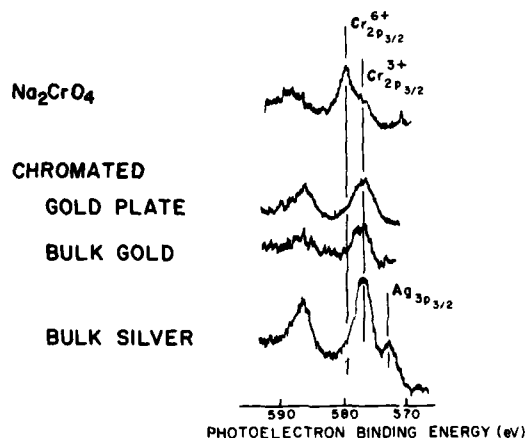
The chromate conversion coatings on Al were shown by XPS to contain large amounts of  $\text{Cr}^{6+}$  [8]. This species is believed to be essential for the coatings to heal any rupture. The chromate films grown as part of this study were also examined by XPS. The literature on chromium oxides binding energies shows binding energies of 579.3 for  $\text{Cr}^{6+}$ , 576.6 for  $\text{Cr}^{3+}$  in  $\text{Cr}_2\text{O}_3$ , and 577.0 eV for  $\text{Cr}^{3+}$  in  $\text{Cr}(\text{OH})_3$  [15,16]. There was no evidence of  $\text{Cr}^{6+}$  species in any of the films grown on the pure metal or bimetallic coupons. (See fig. 3 for representative spectra.)

The absence of  $\text{Cr}^{6+}$  in the chromate film formed on the model Au/Ag samples suggests that flaws in the chromate film would not be able to heal and therefore would be susceptible to corrosive attack. A major factor is the mechanical abrasion suffered by the contacts during use. Deep, linear gouges are visible on the contact

Fig. 3. Chromium  $2p_{3/2}$  and  $2p_{1/2}$  X-ray photoelectron binding energies from sodium dichromate solution evaporated on gold and from chromate films formed on indicated substrates by exposure to the chromating procedure.

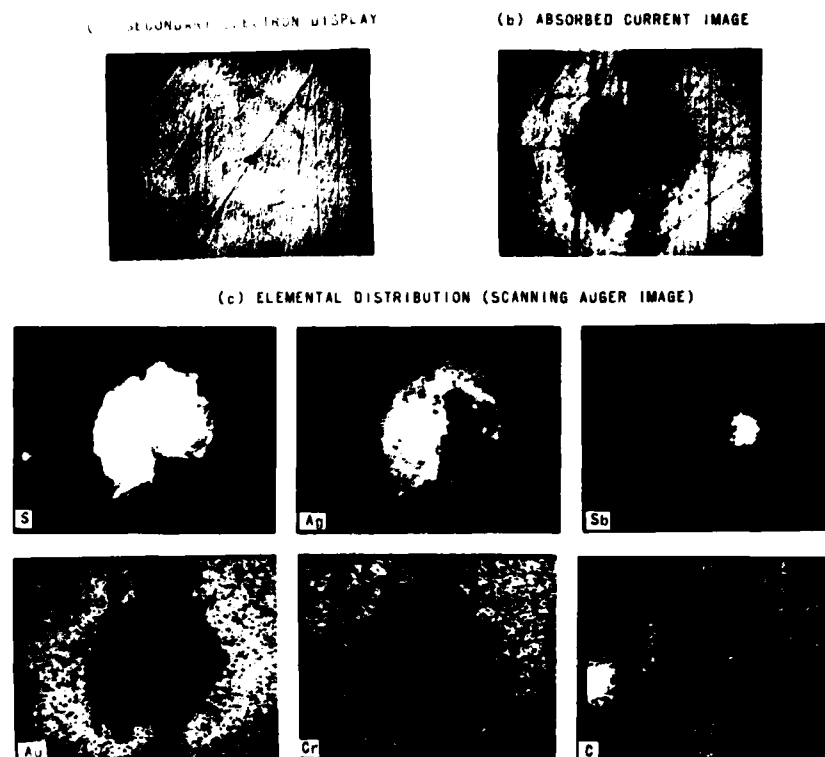
The chromate film growth depends on the local electrochemical potentials. When extraneous sources of potential are present, such as metallic contaminants, the film may not form a protective barrier. This is exemplified in the micrographs of fig. 4, taken from a visibly discolored area ( $\approx 0.08 \times 0.2$  mm) on a chromated Au over Ag over Cu strike on a Be-Cu substrate reference specimen which had been exposed to an accelerated sulfide corrosion test. Despite the chromating, small areas of tarnish had developed within 2 h exposure to 0.5 ppm ammonium sulfide vapor. Fig. 4 is a composite of two types of SEM images plus a set of elemental maps all obtained at the same magnification using a fine beam (diameter  $\approx 0.7 \mu$ ). The central feature is a hairline crack only about  $10 \mu$  long.

Fig. 4. Scanning electron micrographs and scanning Auger electron images of a discolored area on a chromated, gold-over-silver plated specimen, which had been stored for three months after limited exposure to a sulfide atmosphere. (Marker indicates 20  $\mu\text{m}$ .)

and chromium, together with a carbonaceous overlayer. The mottled area in the SEM shows a one-to-one correspondence with the sulfur distribution, this concentration being greatest at and immediately adjacent to the hairline crack. This is also the region of highest concentration of silver, suggesting that the silver had erupted at the crack and had spread from there, reacting with sulfur from the atmosphere and forming the discoloring tarnish.

Although the strongest sulfur signals correlated with the area containing surface-exposed silver, the correspondence was not complete. A semi-circular area (about in its largest dimension) existed for which there was no corresponding concentration of any of the elements expected from either the electroplating or chromate processes. A static multi-element AES trace indicated the unexpected constituent. SAM mapping for this element (Sb in fig. 4) showed it to be local-

ized precisely to the semi-circular area. The proximity to the hairline crack suggests an origin within the undercoating rather than the gold-plated outer surface. The evidence suggests that the presence of the antimony prevented the chromate film from sealing of this pore to silver sulfide migration.

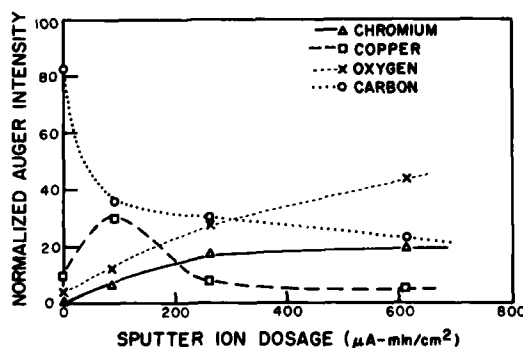
The insulating films are sufficiently thick to be visible; therefore it is not surprising that no Auger signal can be detected from the subjacent gold coating. As shown in the Auger depth profile of fig. 5, the chrome content is low prior to inert-ion sputtering; also present, and in an initial concentration greater than that of chrome, is copper. When sputtering is initiated, the carbon content reduces and the copper content rises sharply; the effect of sputtering on the Cr and O content, however, is a much more gradual increase. As shown by the depth profile, the copper tends to be localized toward the outermost surface, with continued sputter-etching reducing the Cu to a low level.

It thus appears that the copper is directly related to gross film formation, not as an integral constituent of the chromate film but rather as a promoter of the film formation. Empirical studies have shown that the presence of Cu salts,  $\text{CuCl}_2$  in particular, at the contacts during the chromating process do in fact stimulate excess film growth. Given the built-in source of copper (e.g., the substrate material for both male and female contacts) and the active nature of the submarine atmosphere,

Fig. 5. Auger sputter profile of the insulating film which developed during field application of the chromating process to used, male PCB connectors.
